This document provides a case study of a temporary Branch that was built in two weeks. Strategic questions about rebuilding are included to guide your analysis of rebuild options.

Disaster Response Management

3. Quick Branch & Rebuild

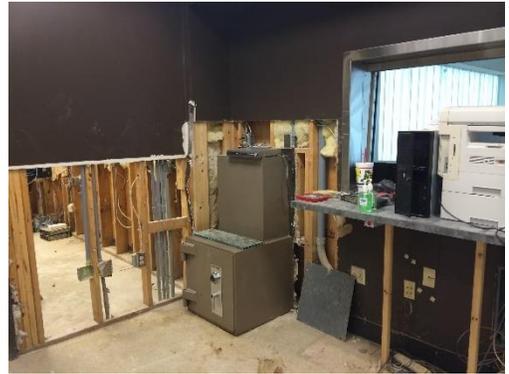
As construction started on the temporary Branch, the interior drywall was gutted to five feet and doors and flooring were removed. Note existing bank equipment was reconditioned and used to support the temporary Branch.

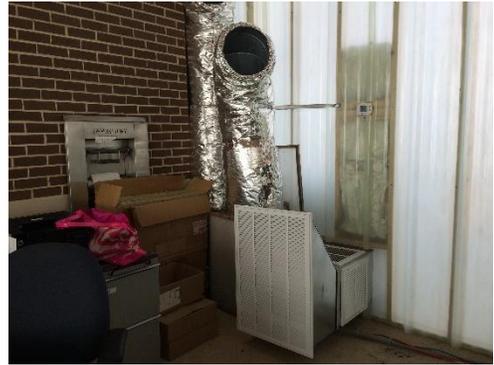
HVAC was diverted from existing HVAC units to the Drive Thru.

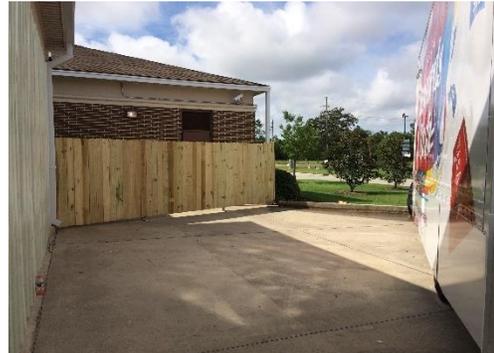
Toilet facilities within the Branch were cleaned up and re used. A 6-foot fence provided a secure path to the Branch interior. Existing Safes and Bank Equipment within the Branch were used.

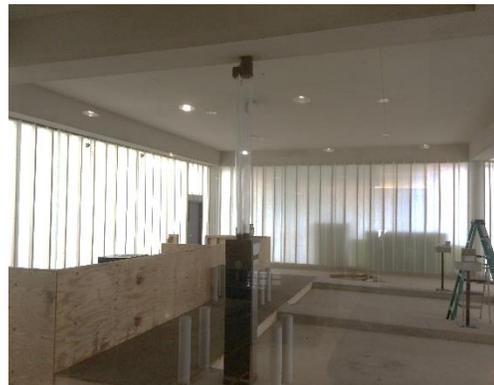
A temporary teller line was built out of Plywood. There was no need for additional lighting as the walls were translucent.

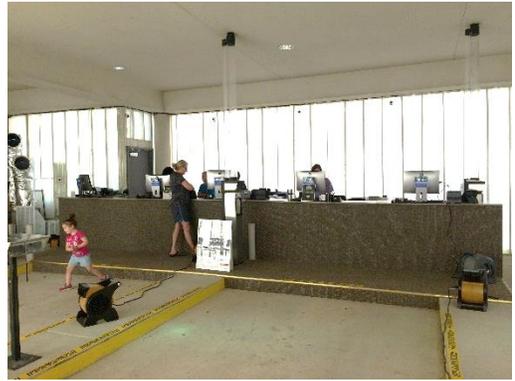
RTU units were left in place and reconditioned. The Plywood teller line was covered with carpet tiles and the laminate counter tops were purchased at a big box store.

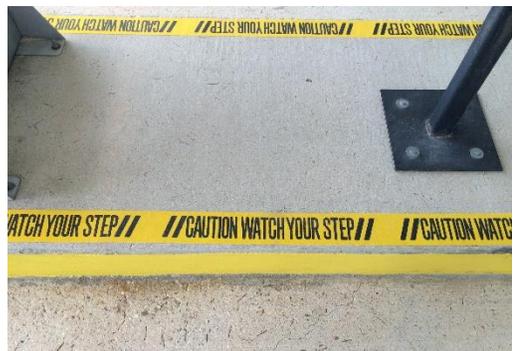
OSHA guidelines for trip hazards were observed as the drive thru islands were elevated.

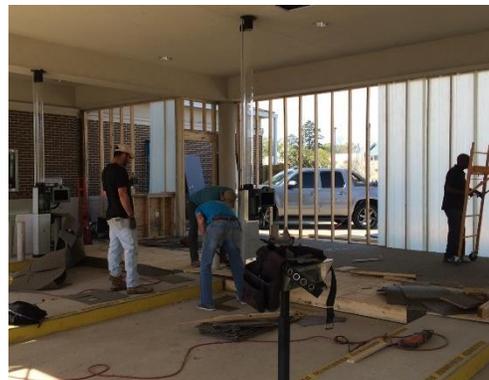
Demo on the Branch started on a Friday evening and was finished by Saturday afternoon.
